Ultrasonic Detectors in Space

By George Studor, Johnson Space Center/Structural Engineering Division
May 22, 2002

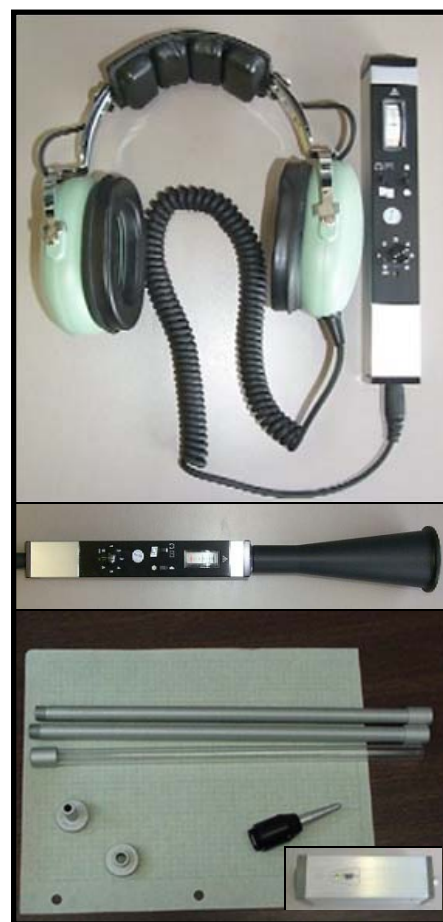
Above: ULD and components

The Ultrasonic Leak Detector (ULD) kit, made by CTRL Systems, Inc. (www.ctrlsys.com), has a simple battery-powered ultrasonic (40KHz) receiver that provides a corresponding audible representation of the level of Ultrasonic noise into a high quality headset. Various attachments allow the microphone to have varying degrees of focus. There is an attachment that also allows the user to detect ultrasound transmitted through structure such as sensing fluid flow-by of an internally leaking valve in a pipe. A transmitter is available to flood a cavity that is supposed to be sealed, to determine if any leaks are present without pressurizing the cavity with air or fluid. Other attachments to the ULD allow the device to discern the condition of bearings, gears, seals, and valves, as well as identify corona discharge to ground and electrical discharge -- making the ULD a valuable tool in

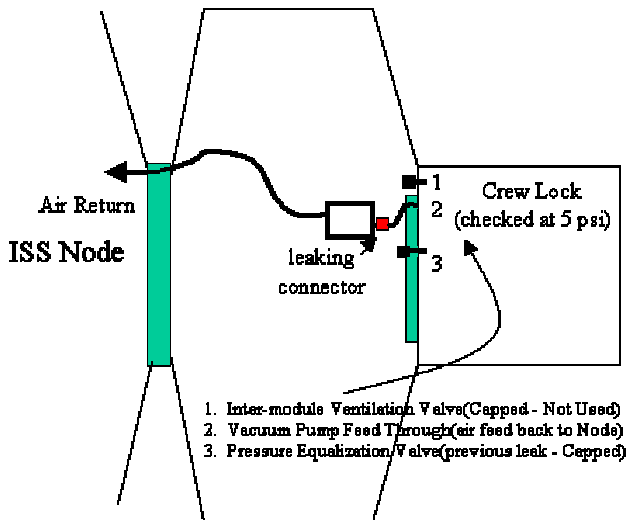
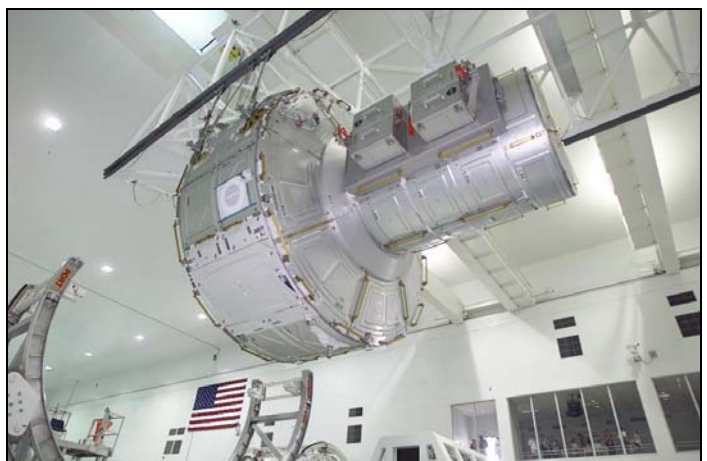
Below: International Space Station (ISS) Airlock
Bottom, right: Airlock Processing at Kennedy Space Center

One suspect capped feed through (Inter-module Ventilation Valve - #1 above) was looked at and determined to not be the leak source. With the leaking connector in the line identified, valves were shut to the line to stop the airflow. Now the mission could continue normally as if nothing were wrong. It became obvious why Ultrasonic Leak Detectors are used on over 10,000 periodic maintenance checks in the JSC Facilities – the tools are easy to use and can quickly determine where leaks or other problems are located.

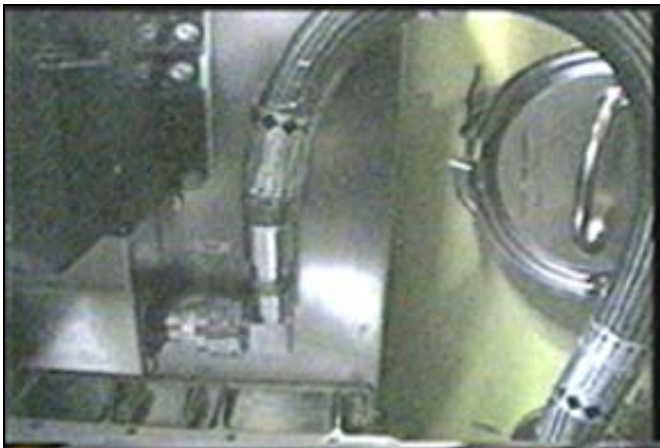
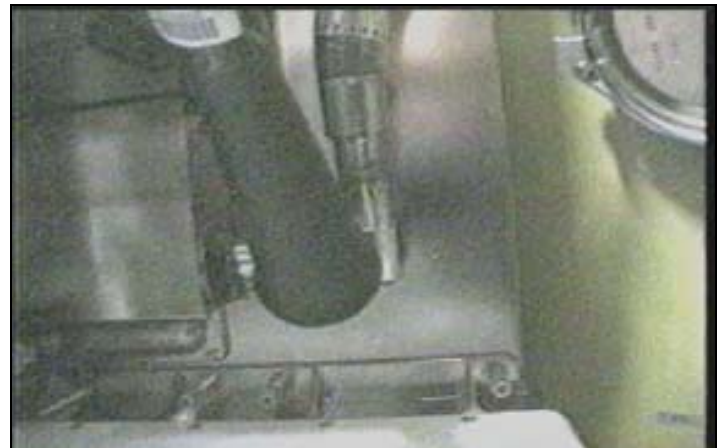
Above: Using the ULD to detect leaks on the International Space Station

No leaks were found around the closed hatch, but a line that recirculates the air pumped out of the crew lock back into the station was leaking at a connector.
