# CASE STUDY

CTRL UL101 Troubleshooter "Ultrasonic Leak Detection Check"  
CTRL Part No. B00033 / Boeing Tool Tag SPL-1473

An example Investigation and Finding on a B777 NLG  
by an Operator

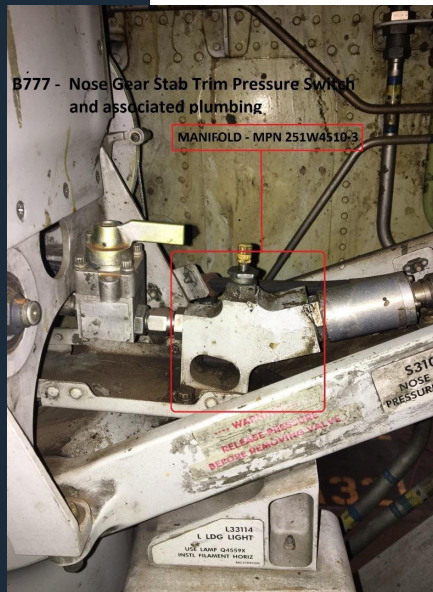
- No leaks could be found, so all components associated with the stabilizer trim pressure switch and plumbing were replaced. Ref Boeing IPC 27-48-04-01 and the photo
- After 24 hours, the struts pressure was again low. The aircraft was placed on AOG. Again, no leaks could be detected using traditional methods. It was a serious condition and if not corrected, could have resulted in a complete loss of NLG pressure and a hard landing if the aircraft had been in operation

- Using the UL101 test equipment, the complete stabilizer trim pressure switch and plumbing system was investigated. An air leak was found with the manifold assembly. This part had been previously replaced to rectify the fault and therefore was determined to be defective from stock. A replaced part being the source of the leak was unexpected, and without the UL101's ease of use, it would not have been easily found.
- Although the aircraft experienced extended AOG downtime, the operator found and confirmed the defective part as the cause of the leak by using the UL101. This saved further troubleshooting time and eliminated the need to ask the operator's specialist Landing Gear Technicians from its home base to investigate and rectify the fault, which would have delayed the aircraft further.
